Vacation-Home

After this historic beachfront home burned to the ground, its high-profile owner decided to never let it happen again

by Charles Wardell

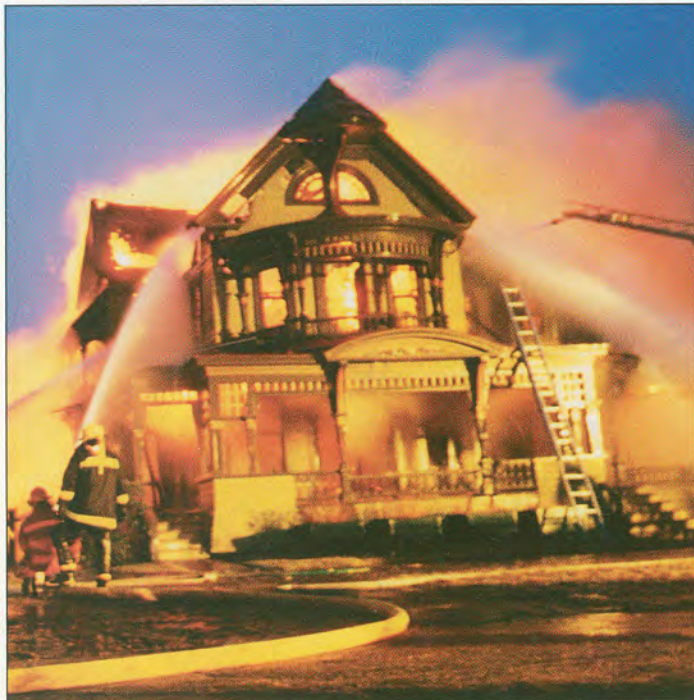
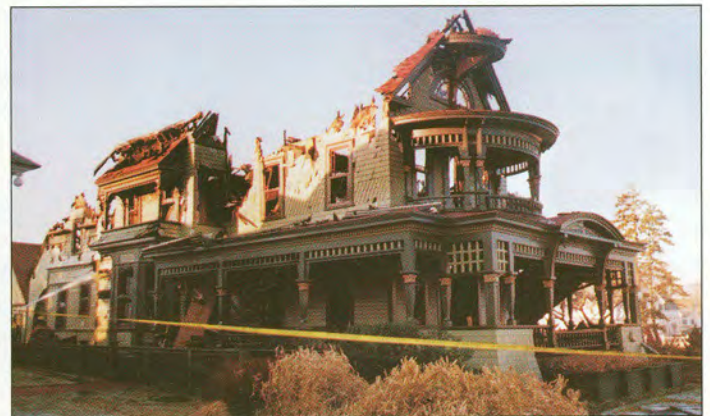
Shortly after the renovation of the Corbin-Norton House on Martha's Vineyard, a fire sparked by an electrical short circuit reduced the unoccupied home to cinders. Faced with the ruin of the once-grand Victorian, its owner decided to restore it immediately — adding a state-of-the-art fire and security system in the rebuild.

Then disaster struck. In February 2001 a short circuit in an electrical wire set off a blaze that reduced the unoccupied home to cinders. The home's smoke detectors malfunctioned, letting the fire quietly smolder in one room for approximately four hours, until it got hot enough to melt the windows. When that happened, the rush of oxygen caused the room to burst into flames, which then spread quickly throughout the house. Firefighters made a heroic effort to keep the fire from spreading to adjacent homes, but that was the best they could hope for. The blaze was unstoppable.
